Karst Invertebrate Survey

Technical Report

**KARST INVERTEBRATE TECHNICAL REPORT
FOR US 281 FROM LOOP 1604 TO BORGFELD ROAD, BEXAR
COUNTY, TEXAS**

28 December 2011

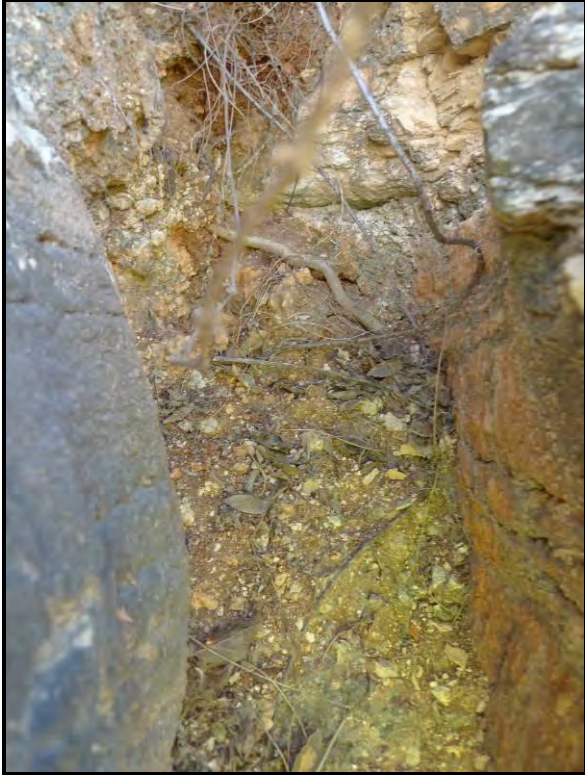
Figure 183. Interior of feature 281-104.

281-104, solution cavity This consists of two solution cavities in the east US 281 road cut, one of which is associated with a fracture (Figure 182). The north cavity is 0.8 m (2.6 ft) wide, 1.2 m (3.9 ft) tall, and extends into the road cut for 0.2 m (0.7 ft). The south cavity is 0.4 m (1.3 ft) wide, 1.3 m (4.3 ft) tall, and extends into the road cut for 0.7 m (2.3 ft). These contain coarse infill of rocks that is likely a consequence of road cut excavation (Figure 183). This feature was not recommended for excavation (Table 1).
